Eastern Municipal Water District Final Pilot Plant Report Purified Water Replenishment Brine Concentration Pilot Project Client: EMWD 2270 TRUMBLE ROAD PERRIS, CALIFORNIA Date: October 7, 2021 CD

1.1 Project Background

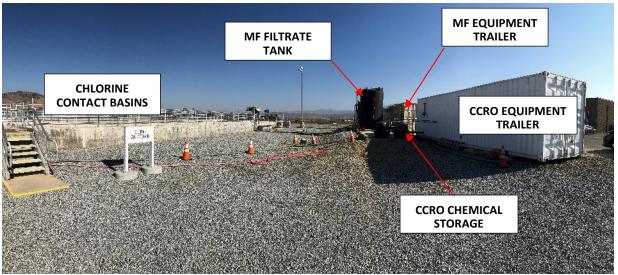
Figure 1-1 Pilot Plant and Adjacent Chlorine Contact Basins at the SJVRWRF

CCRO process. Filtrate was pumped from the MF Filtrate Tank to the CCRO system by a booster pump located prior to the CCRO high pressure pump. Both CCRO permeate and brine were returned back to the Chlorine Contact Basin.

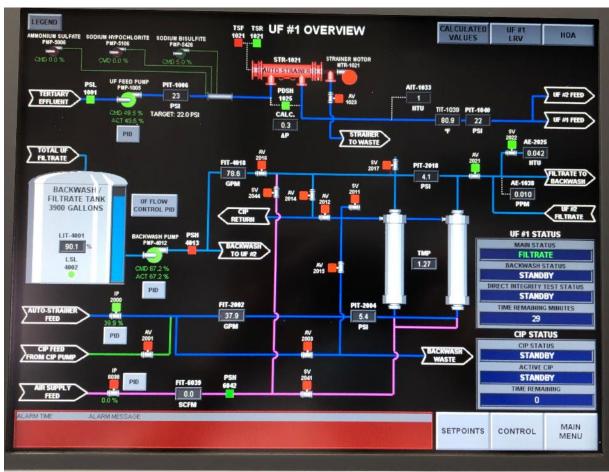
Figure 1-2 HMI Screen for MF Train 1

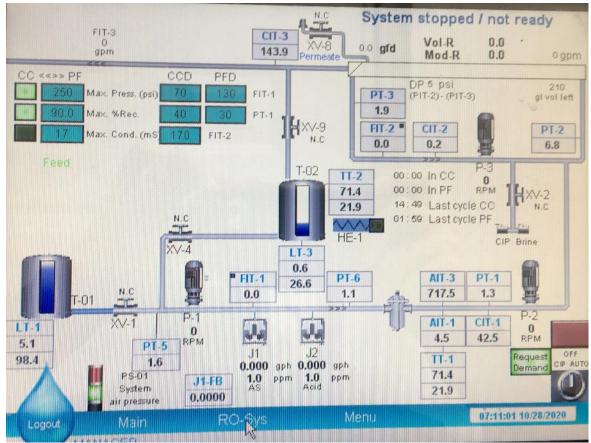
Figure 1-3 HMI Overview Screen for CCRO

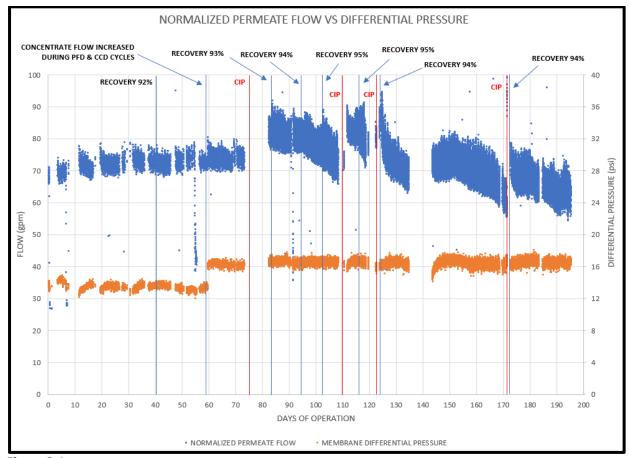
Figure 2-1 Normalized Permeate Flow & ΔP (~75 to 95% Recovery)

A 2-step CIP was performed on the membranes over April 12 and 13 (Day 172 and 173 respectively) based on a normalized permeate flow decrease of approximately 15% from the baseline. A slight reduction in the normalized salt passage could also be detected, suggesting the foulant was more organic than inorganic. Prior to initiating the CIP, a tail element was pulled for autopsy and a new membrane was installed as a replacement.

The pilot's final run was initiated on April 13, with the same setpoints as those used on the previous run. The intent of operating with identical conditions was to confirm the repeatability of operating at 94 percent recovery. The final run concluded on May 7 (Day 196) prior to a series of programmed power outages planned, which were planned to take place over a 2-week period on the full-scale facility. At this time, the pilot had operated for approximately 24 days and normalized permeate flow losses were approximately 10% off of the estimated baseline. No

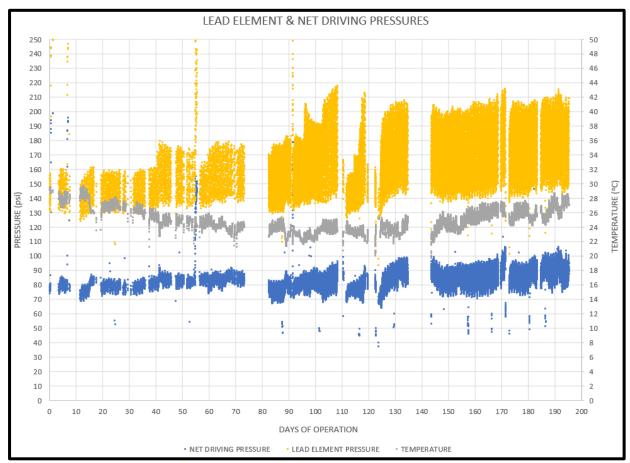
Figure 2-3

Feed Pressure vs NDP vs Temperature (~75 to 95% Recovery)

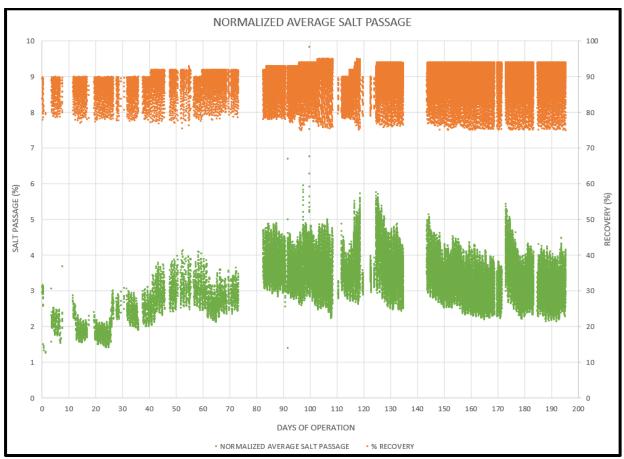
Figure 2-5 Normalized Avg Salt Passage vs Recovery (~75 to 95% Recovery)

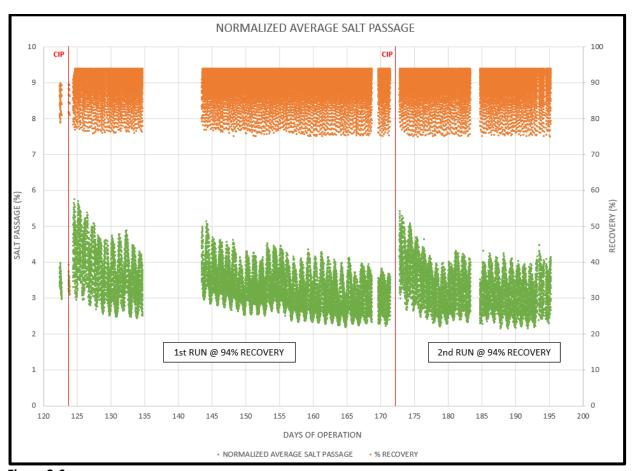
Figure 2-6 Normalized Avg Salt Passage vs Recovery (~75 to 94% Recovery) Feb. 23 to May 7

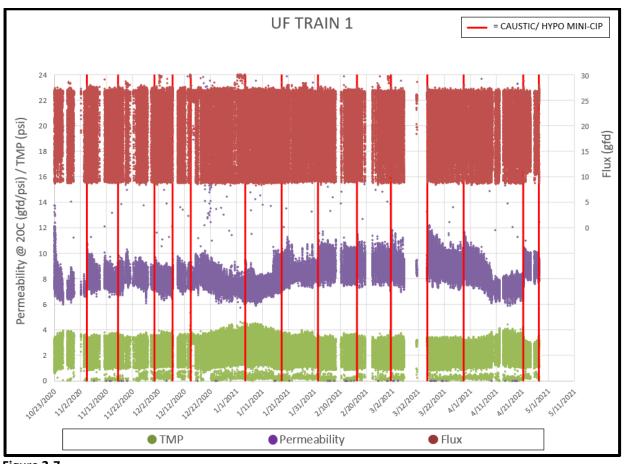
Figure 2-7 UF Train 1 Cumulative Performance (Oct-23-2020 to May-1-2021)

Based on the transmembrane pressure (TMP) and permeability data, membrane performance was relatively stable and only minor fouling was observed throughout the trial. Although gradual declines in permeability (and concurrent rise in TMP) were observed on occasion, especially when the mini-CIP frequency extended beyond a two-week period, the mini-CIPs were generally effective in restoring the membrane's baseline performance and a full-strength CIP was never performed. In some cases, membrane performance was not fully restored after the mini-CIP event, but was restored after the subsequent cleaning two weeks later. Because of the intermittent use of the MF pilot's sodium hypochlorite dosing system, air locks in the dosing line did occur and were not always fully purged during the cleaning cycle resulting in Train 1 receiving less available chlorine compared with Train 2. This issue could be remedied by priming the line manually before the initiation of the first clean.

Figure 3-7 and Figure 3-8 below present the cumulative trends of performance data for UF Trains 1 and 2 that have been collected off the HMI over the testing cycle. The caustic/hypo mini-CIP events performed on the membranes are noted with red lines overlaid on these figures. As noted earlier, the large variation in flux data (red) is a result of the feed pump control algorithm, which was configured to ensure a constant level in the Filtrate Tank while avoiding overflow conditions.

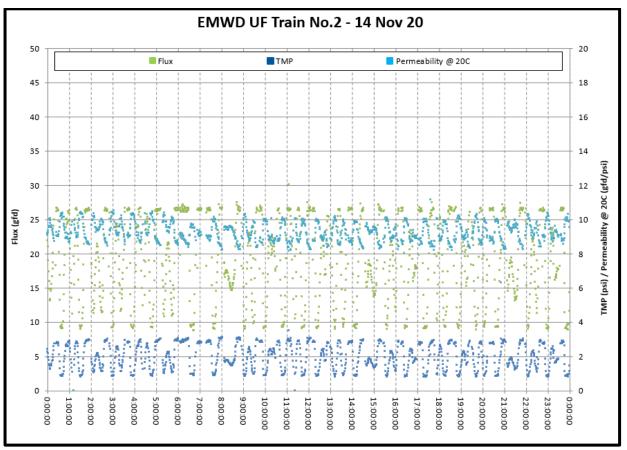
Figure 2-9 Representative 24-hr Run Cycle (Train 2)

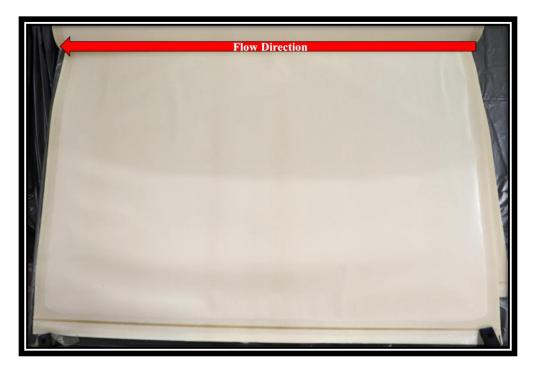
Figure 17: Membrane unraveled.

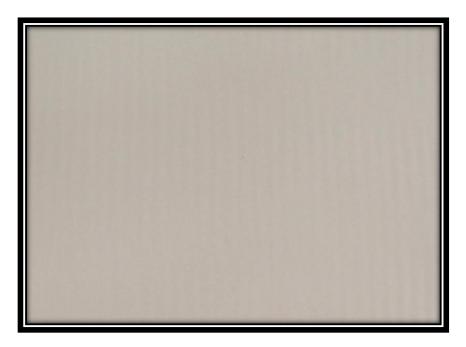
Light foulant deposition was observed on the membrane leaves.

Figure 18: Light foulant deposition was observed on the membrane leaves.

- Membrane was in very good visual condition upon arrival. A light foulant deposition was observed on the membrane leaves. However, the foulant density was $\sim 0.19 \,\mu\text{g/cm}^2$ when dehydrated, which was considered extremely low;
- Initial wet testing found that the membrane flux to be ~2.68% below manufacturer's nominal specification; and
- Flat sheet testing with coupons collected along the flow path of the membrane performed:

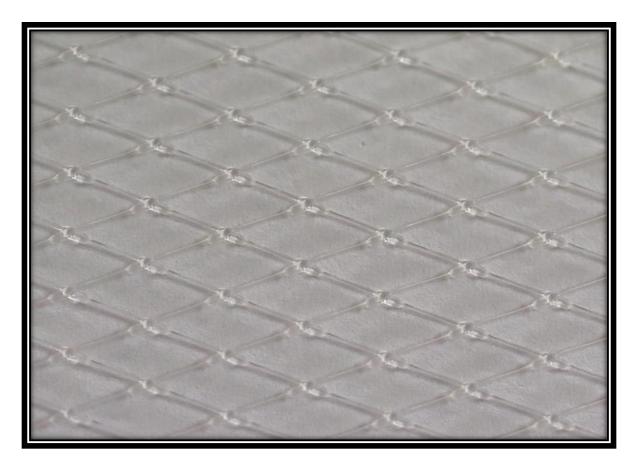
The feed spacers appeared clean and intact to the naked eye.

Figure 21: The feed spacers appeared clean and intact to the naked eye.

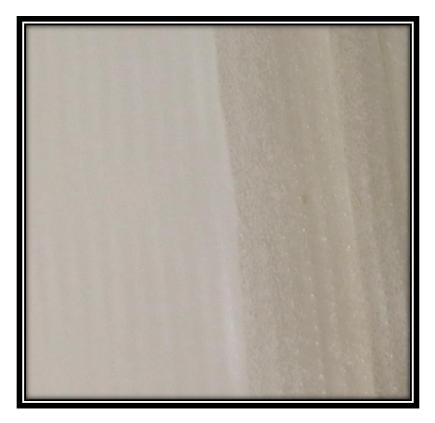
No osmotic bubbling was observed along the glue line.

Figure 22: No osmotic bubbling was observed along the glue line.

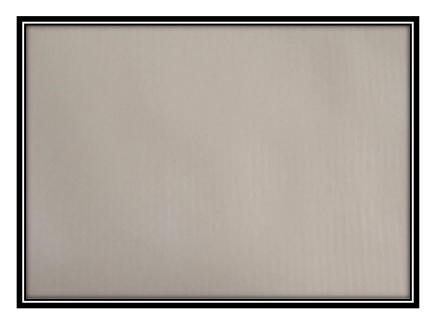
The permeate side of the membrane appeared clean and intact to the naked eye.

Figure 24: The permeate side of the membrane appeared clean and intact to the naked eye.

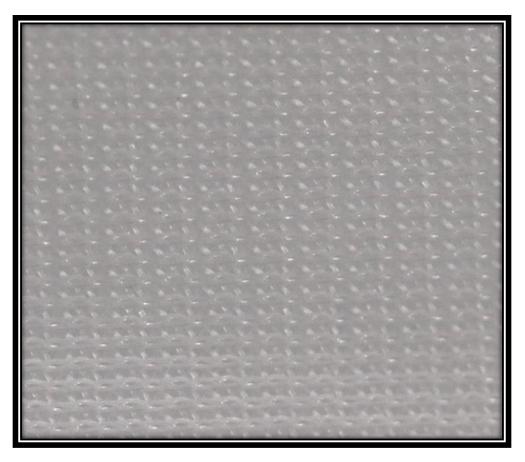
The permeate spacers appeared clean and intact to the naked eye.

Figure 25: The permeate spacers appeared clean and intact to the naked eye.

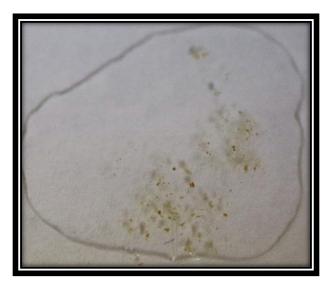
No effervescence was observed upon the addition of acid to the dehydrated foulant.

Figure 27: No effervescence was observed upon the addition of acid to the dehydrated foulant.

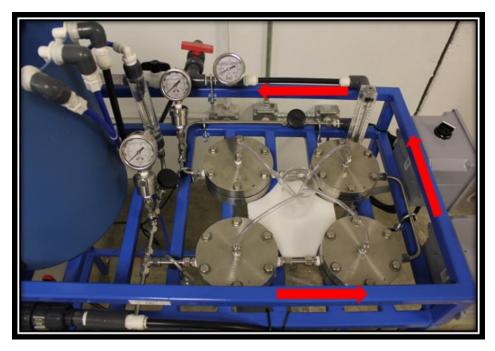
Initial cell testing found permeability to be greater than the manufacturer's specification, though salt rejection was within specification.

Figure 28: Cell test using 2000 ppm NaCl solution at 225 PSI.

- Initial cell testing, performed on coupons that had been soaked in deionized water for 24 hours prior to testing, found permeability to be approximately 20% greater than the manufacturer's nominal specification, though salt rejection was within specification.

- A follow up cleaning was performed with 2% AWC C-234, a low pH chemical cleaner. The cleaning was performed at pH ~1.7 and 27°C for 2 hours. A marginal decrease in permeability was observed, with a slight increase in salt rejection.

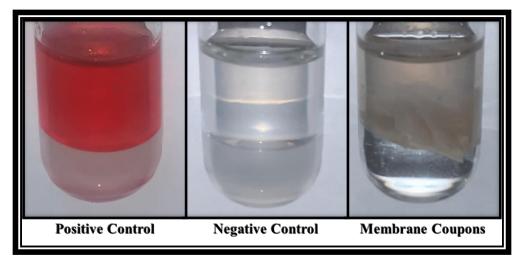
The membrane coupons tested negative for halogen exposure.

Figure 32: The membrane coupons tested negative for halogen exposure.

Although such high permeability relative to the nominal specification could have been indicative of underlying membrane deterioration due to minor halogenation (oxidant damage), the Fujiwara test was negative and salt rejection was within specification. The results suggest that the membrane was substantially more permeable than would have been expected based on the manufacturer's data sheet.

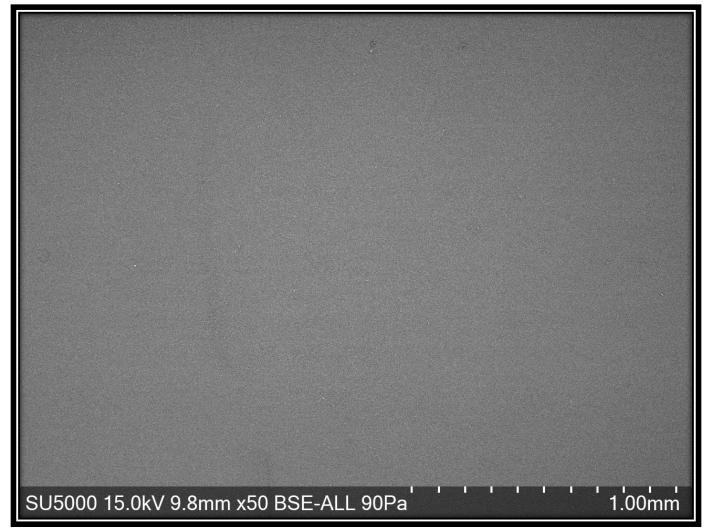
Figure 34: Electron micrograph of the membrane surface at 50X magnification.

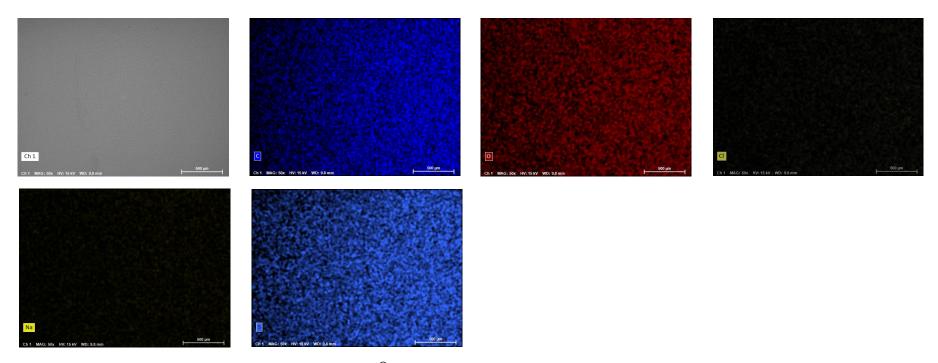
No inorganic deposits were found on the membrane surface.

Figure 35: Prismatic Elemental Delineation (PED[®]) of membrane surface at 50X magnification. Deposits found: No inorganic deposits were found.

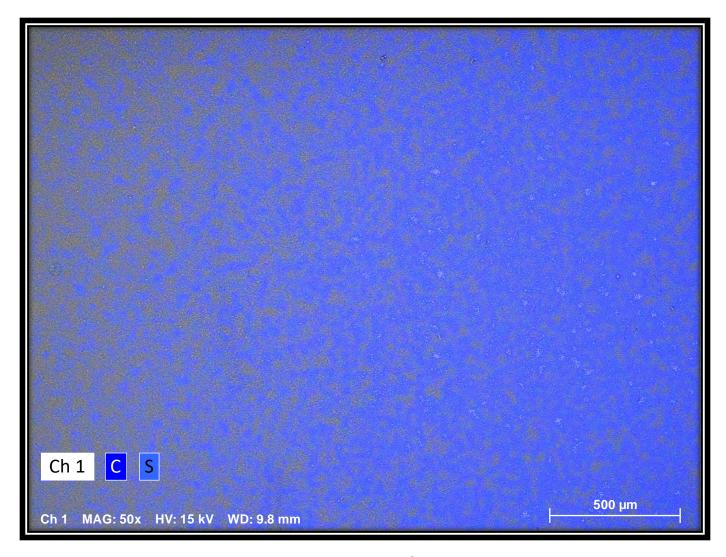
Figure 36: Superimposed Elemental Imaging (SEI[®]): No inorganic deposits were found.

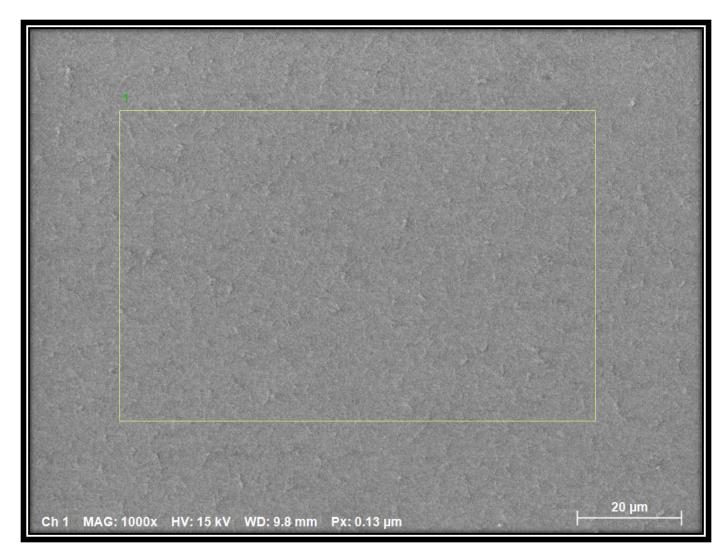
Figure 37: Electron micrograph of the membrane surface at 1000X magnification (Spectrum 1).

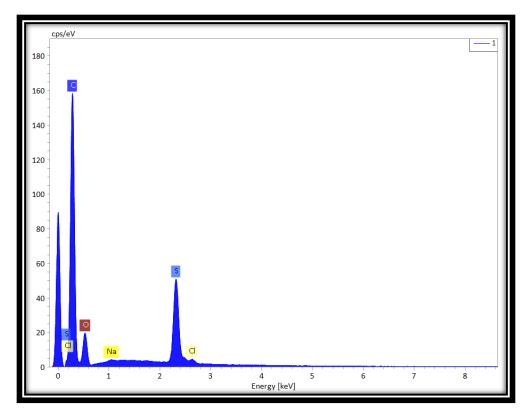
Figure 38: EDS and composition bar graph analysis of the membrane deposit from Spectrum 1.

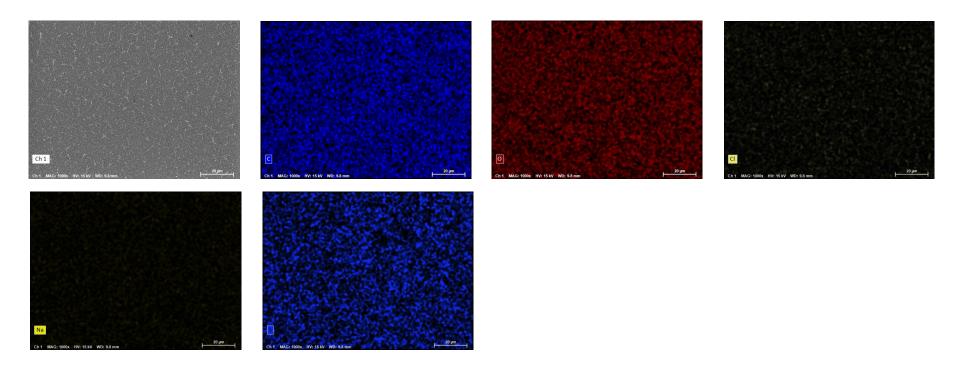
Figure 39: Prismatic Elemental Delineation (PED[®]) of membrane surface at 1000X magnification. Deposits found: No inorganic deposits were found other than sodium chloride residue from membrane performance testing.

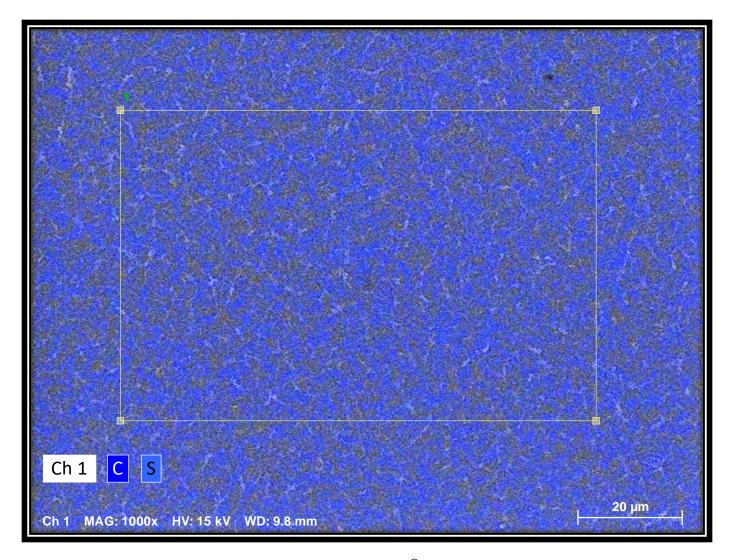
Figure 40: Superimposed Elemental Imaging (SEI[®]): No inorganic deposits were found.

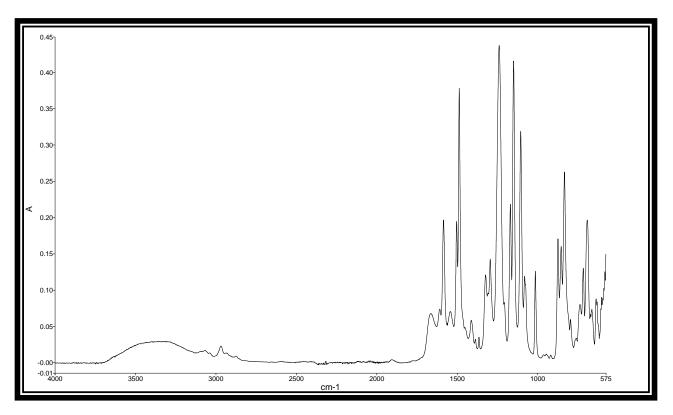
The spectrum of the fouled membrane surface had a strong correlation to the virgin membrane surface (99% correlation).

Figure 41: FTIR spectrum of the fouled membrane surface.

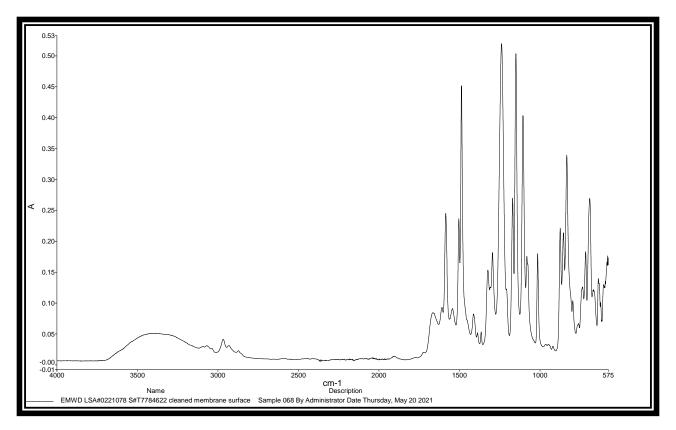
A virgin BW30XFR is comparable to a CR100 according to Dupont. The cleaned surface was found to strongly correlate to a virgin membrane.

Figure 42: FTIR spectrum of the cleaned membrane surface.

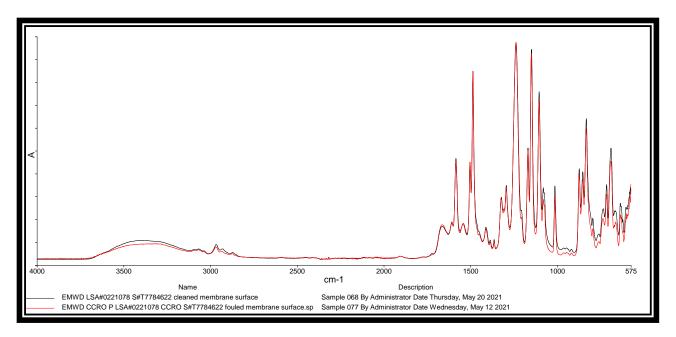
Figure 43: FTIR spectrum of the cleaned membrane surface had a ~99% correlation to the fouled membrane surface.

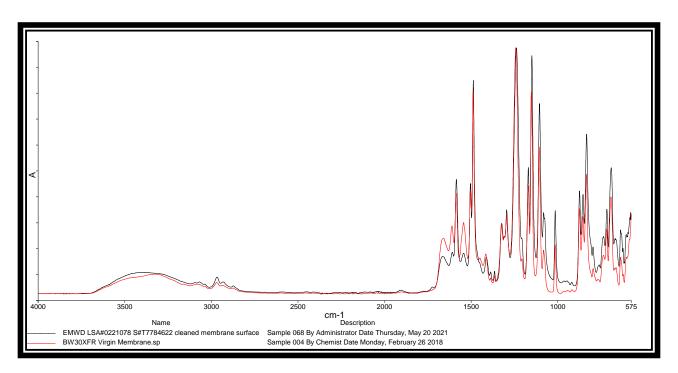
Figure 44: FTIR spectrum of the cleaned membrane surface had a ~94% correlation to a virgin membrane.

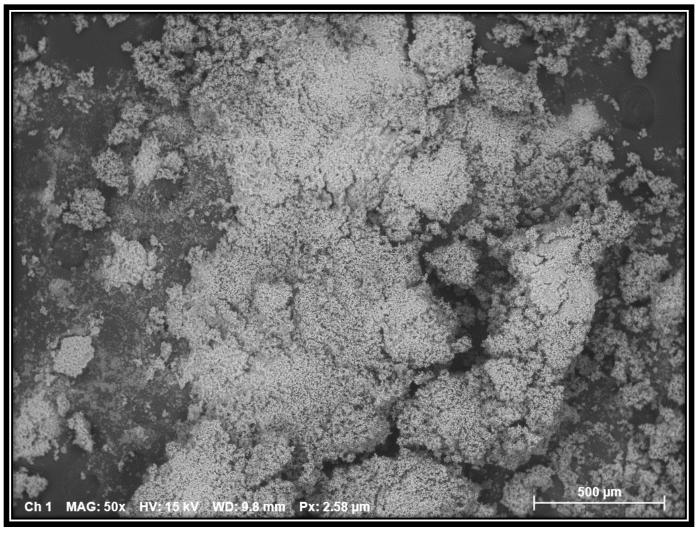
Figure 48: Electron micrograph of the deposit at 50X magnification.

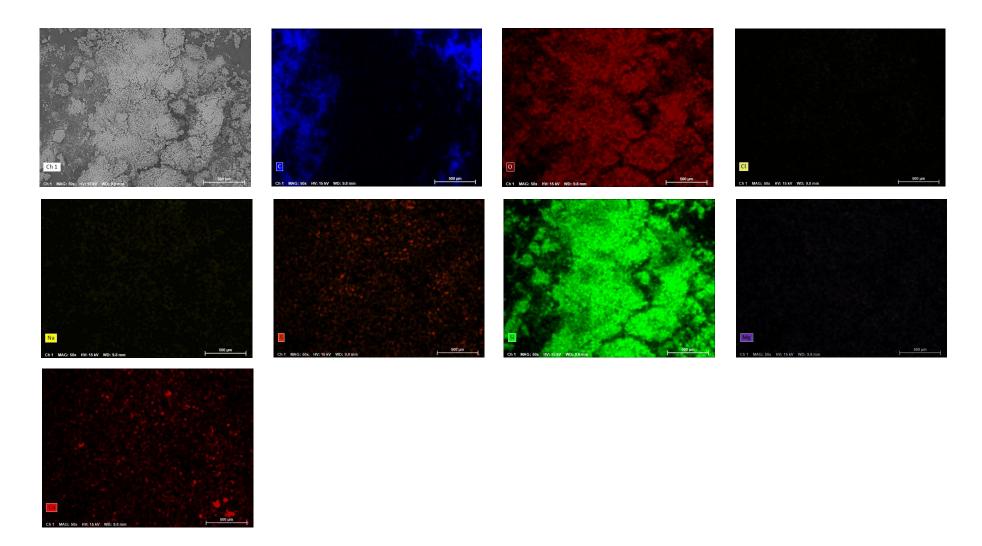
Figure 49: Prismatic Elemental Delineation (PED[®]) of the deposit at 50X magnification. Deposits found: Silicate-based material with some calcium sulfate inclusions.

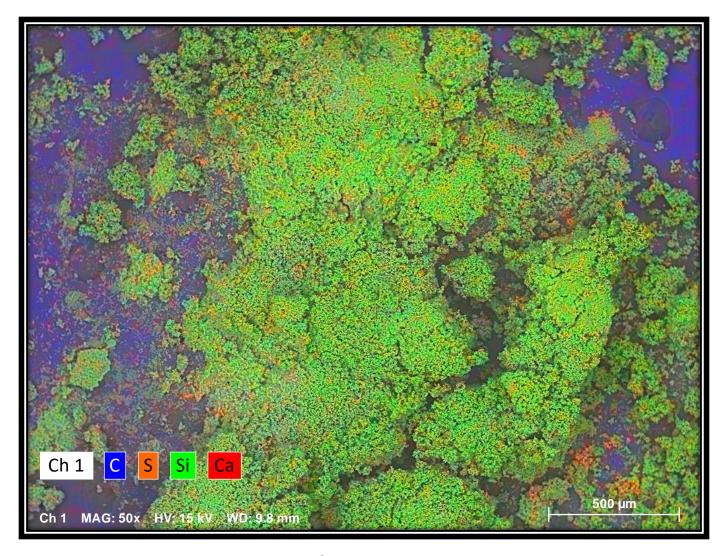
Figure 50: Superimposed Elemental Imaging (SEI[®]): Silicate-based material with some calcium sulfate inclusions.

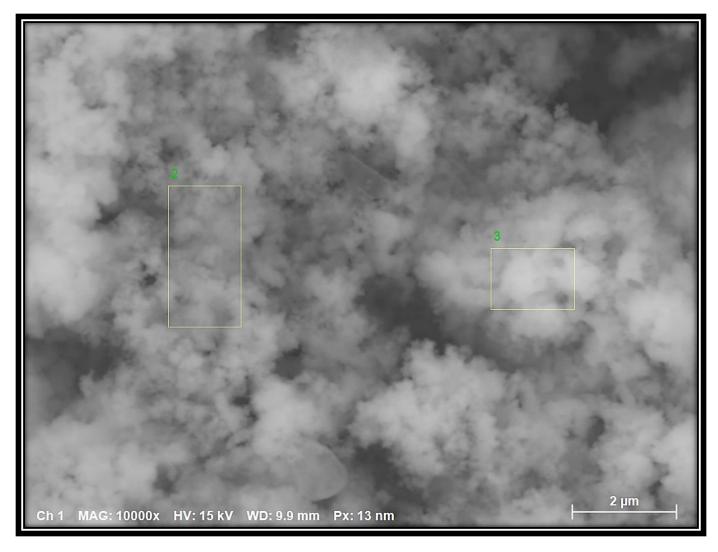
Figure 51: Electron micrograph of the deposit at 10000X magnification (Spectrum 2 & Spectrum 3).

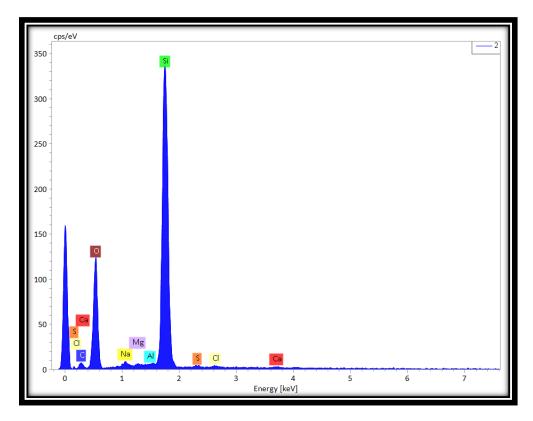
Figure 52: EDS and composition bar graph analysis of the deposit from Spectrum 2.

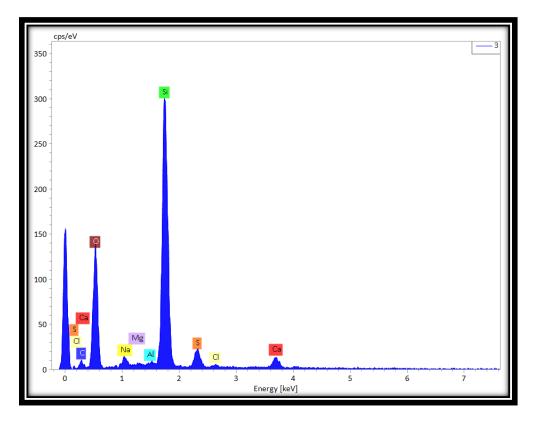
Figure 53: EDS and composition bar graph analysis of the deposit from Spectrum 3.

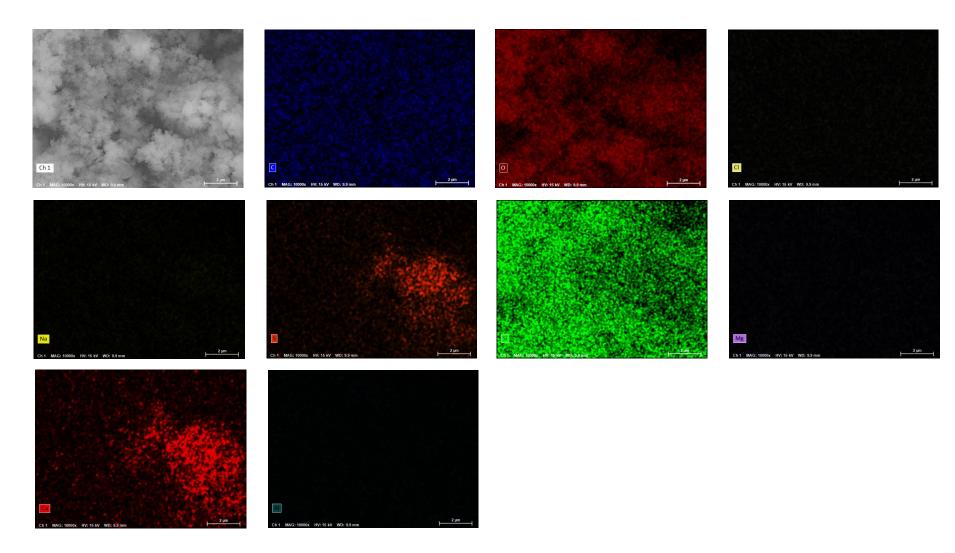
Figure 54: Prismatic Elemental Delineation (PED[®]) of the deposit at 10000X magnification. Deposits found: Silicate-based material with some calcium sulfate inclusions.

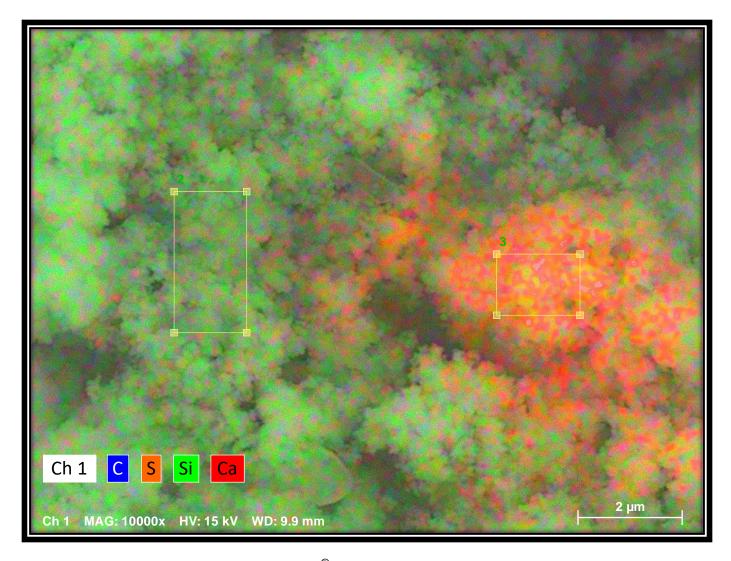
Figure 55: Superimposed Elemental Imaging (SEI[®]): Silicate-based material with some calcium sulfate inclusions.

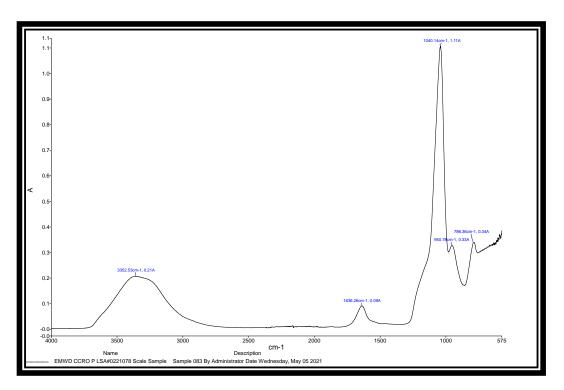
The spectrum of the sample had peaks associated with silica. A library search found that the material correlated well with silica gel.

Figure 56:FTIR spectrum of the scale sample.

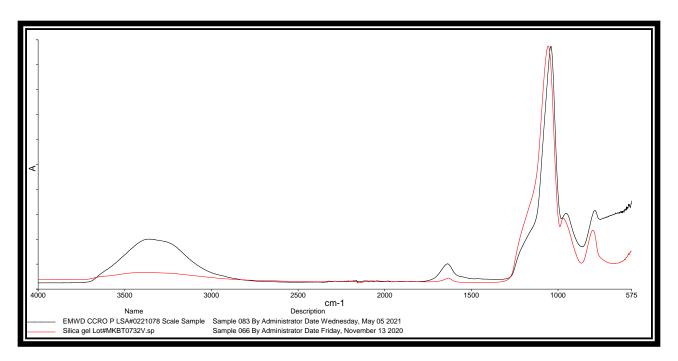
Figure 57:FTIR spectrum of the scale sample had a ~88% correlation to silica.
